THE APOLLO 14 DOCKING ANOMALY

By Robert D. Langley*

ABSTRACT

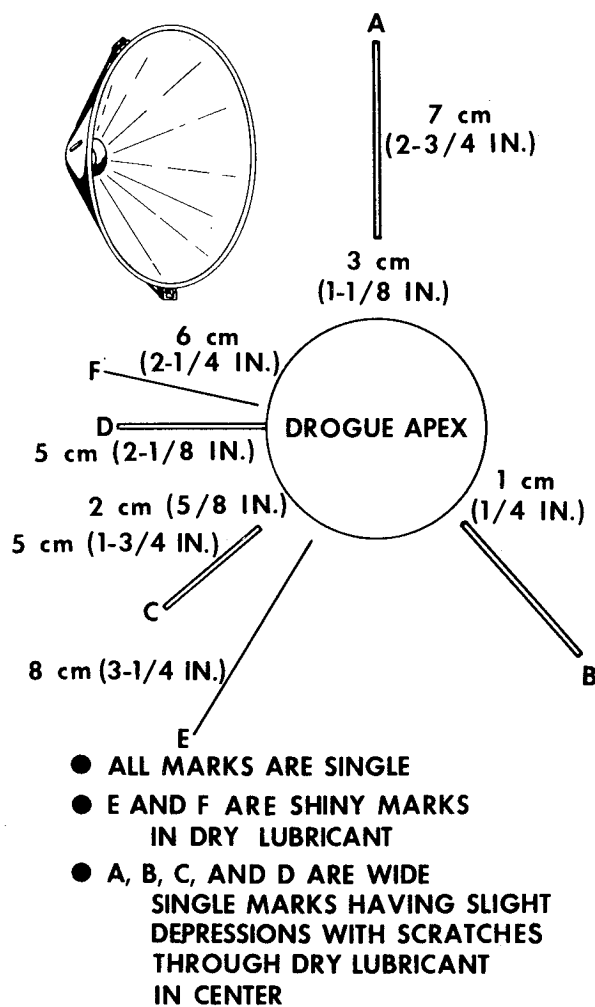
Figure 8. - Drogue assembly and location of radial marks.

After docking, the crew examined the probe and drogue and no abnormal operations could be observed; however, there were marks on the drogue, as is shown in figure 8. Although subsequent docking functions were completely normal, the docking probe was returned with the CM.

3. Each of the six marks on the drogue resulted from separate contacts by the probe head (fig. 8). A docking impact with locked capture latches should result in three double marks (to match the latch hooks) within 2.54 centimeters (1 inch) of the drogue socket.

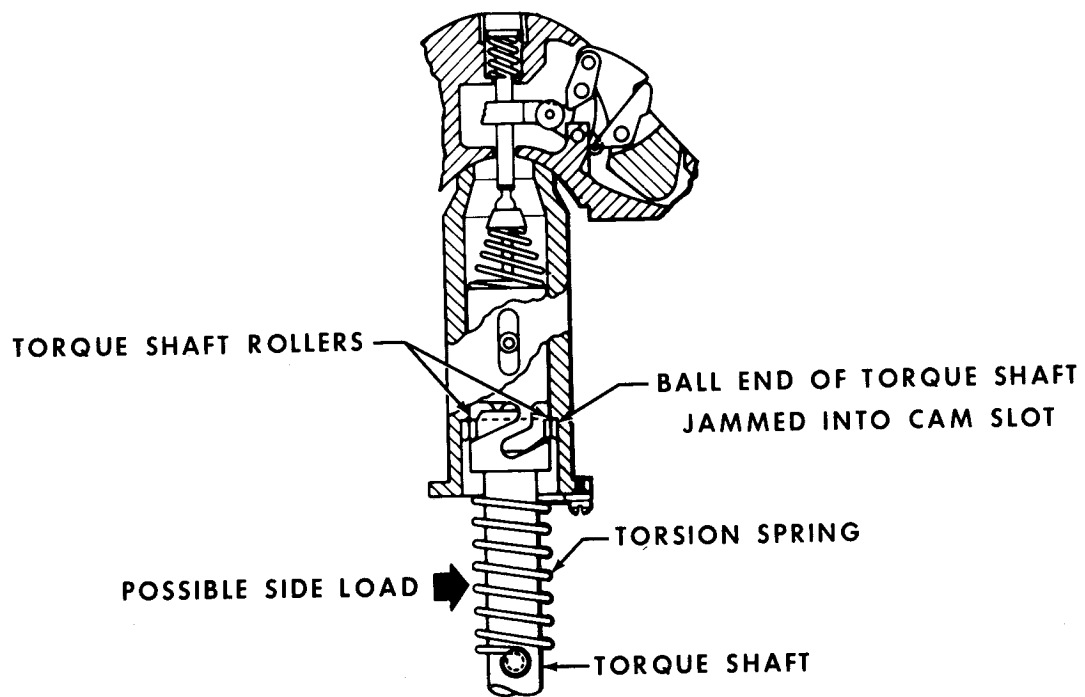
Figure 9. - Side-load reaction on torque-shaft operation.

Coincidental with the Apollo 14 investigation, acceptance testing was being performed on the Apollo 16 docking probe when the capture latches failed in a manner symptomatic of the Apollo 14 anomaly. It was determined that, for a given torque-shaft alignment and the lateral load resulting from the torsion spring (fig. 9), the ball end of the shaft would fall into the cam slot. Then, a friction lock would occur between the ball and pin, preventing the ball from riding out of the cam slot. This, in turn, would prevent subsequent movement of the cam and spider train. Upon disassembly, the torque-shaft ball was found to be galled severely.

After the Apollo 16 probe capture-latch problem, attempts were made to duplicate the problem on the Apollo 14 probe. With the latch assembly in a horizontal position so that the weight of the shaft added to torsion-spring lateral load, one malfunction was experienced during 60 latch cycles. This also remained a potential failure mode.

The cause of the Apollo 14 docking anomaly was either (1) foreign material (that was subsequently lost) restricting mechanical operation or (2) jamming of the cam. To ensure proper performance for future systems, cleanliness requirements were improved and a design change was implemented to prevent jamming of the cam. Since then, the Apollo 15 and 16 missions have been completed successfully without recurrence of the docking problem.

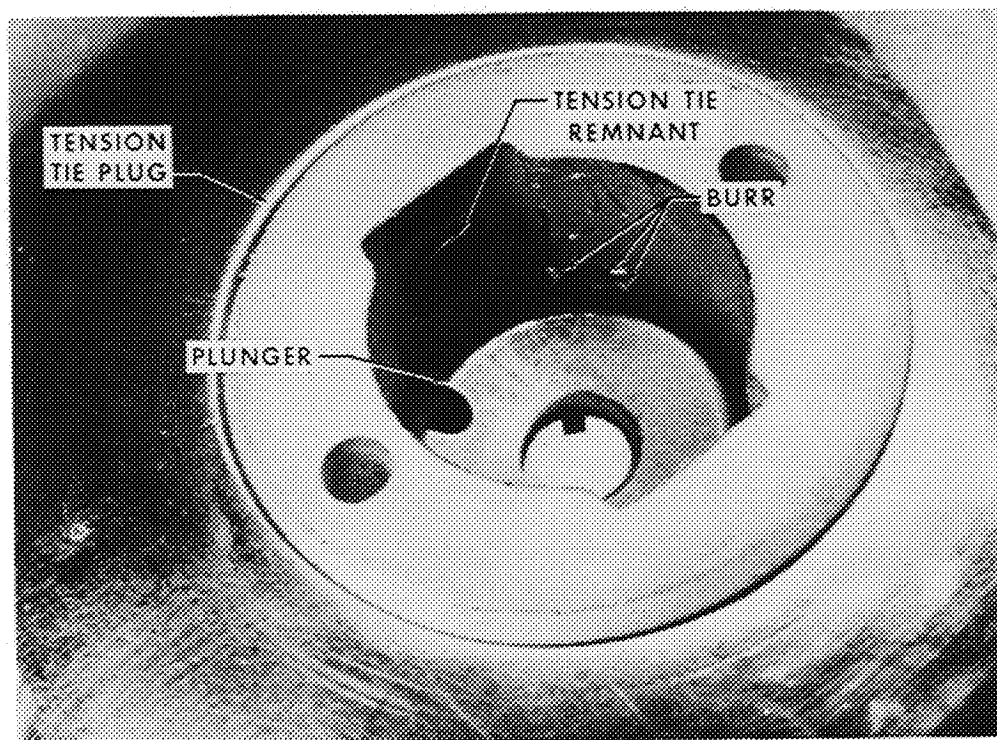
Figure 10. - Scratches and burrs adjacent to capture-latch plunger.

A visual inspection of the probe head revealed several small scratches and burrs on the inner wall of the tension-tie bushing (fig. 10). The scratches were caused by an object moving in the aft direction; the burrs were the material buildup. This burring could have been caused by a foreign particle lodged between the plunger and the wall of the bushing because the initial motion of the plunger is in the aft direction when the

capture hooks are depressed. Therefore, foreign particles in the area of the capture-latch plunger were considered a potential failure mode.

During disassembly of the probe, 12 contaminant particles were found. Three of the particles, which were foreign to the probe, were iron oxide, double-back tape, and cadmium particles. The largest of the 12 particles was 0.15 centimeter (0.060 inch) long, and, of those particles large enough to cause mechanical interference, none were hard enough to prevent operation of the mechanism.
